Aquamaintain LTD

Case Study

Badshot Lea Pond Restoration

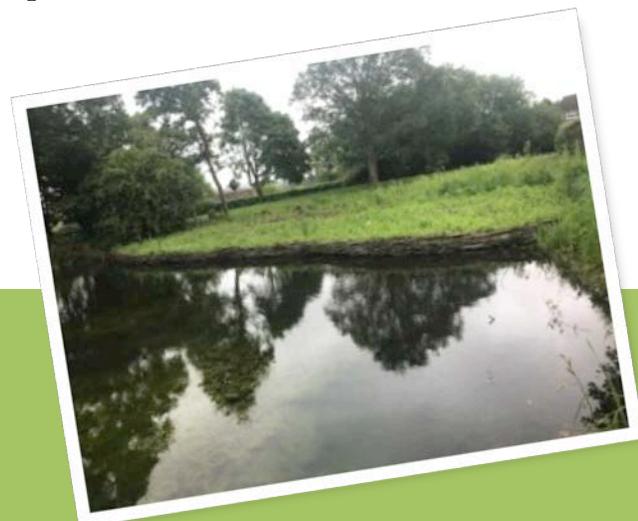
Reed mace and other vegetation, which was encroaching from the South and West margins, dominated much of the pond. This along with significant silt formation had reduced water depths in certain areas as well as reducing the surface area of the pond. Bankside willows were shading out large areas, increasing nutrient build up and leading to blocking of the outlet culvert, which had resulted in flooding in the past. Algae and Duckweed had dominated the open water area and the aquatic system was in the advanced stages of eutrophication.

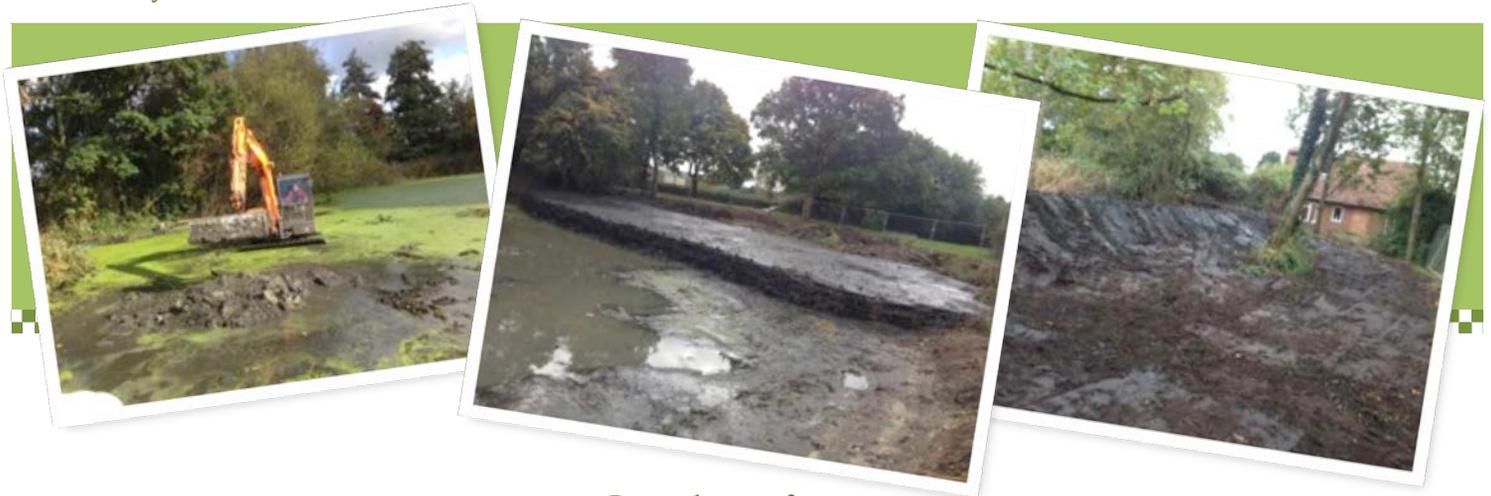
“excess vegetation and sediment, which was placed behind a woven Hazel facine”

Water levels were lowered by clearing the pond outlet and pumping the water away. A tracked excavator was used to clear the excess vegetation and sediment, which was placed behind a woven Hazel facine installed across two key areas.

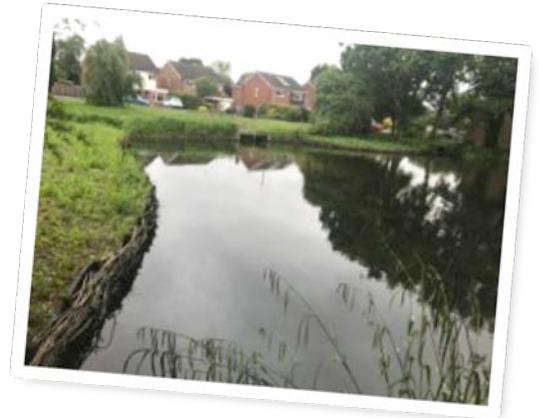
To overcome potential future flooding issues bank levels were raised by installing a plastic sheet-piling cut off wall along the southern embankment.

This was dressed with topsoil and graded to blend in with the rest of the parkland surroundings.
