Aquamaintain LTD

Case Study

Boveney Ditch, Eaton Wick, Windsor

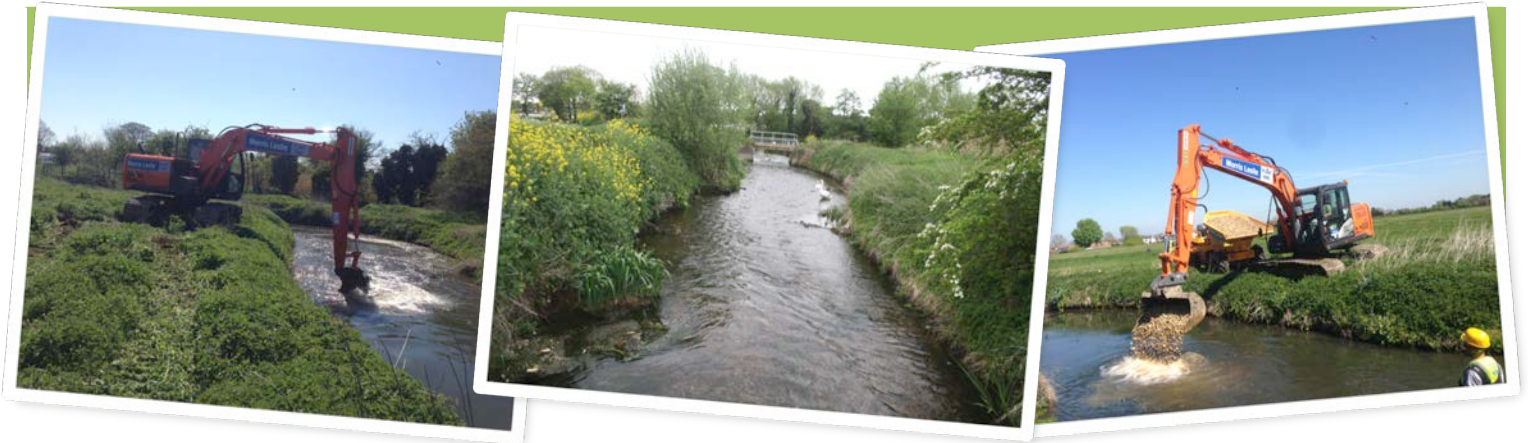
100 tonnes of 40mm – 60mm gravel reject stone was introduced into the channel over 4 different sites.

At the confluence of the channel where it meets the Thames, flow deflectors were positioned to create cover for traversing fish moving into the channel.

Gravels were positioned over natural features in the river bed to construct pool and riffle habitat suitable for spawning and migrating fish.
