# Aquamaintain LTD

## Case Study

### Pymmes Brook, De-Culverting Oak Hill Park, Barnett

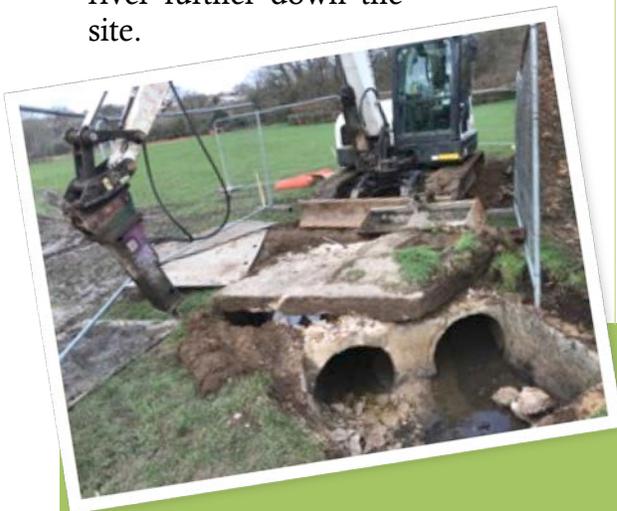
A tributary of the Pymmes Brook flowed through the Reserve as a culvert which ran beneath the woodland & amenity grassland in the park, before entering the main river further down the site.
